**PROJECT GROUP NO. NT-003 020 B
ENGR. REPORT NO. 5.2120**

**U.S. Naval Supply Research & Development Facility
Bayonne, New Jersey**

INTERIM REPORT ON THE INSTALLATION
OF
CARBON MONOXIDE ELIMINATOR MUFFLERS

ENGINEERING REPORT NO. 5.2120
Project Group No. NT-003-020(b)

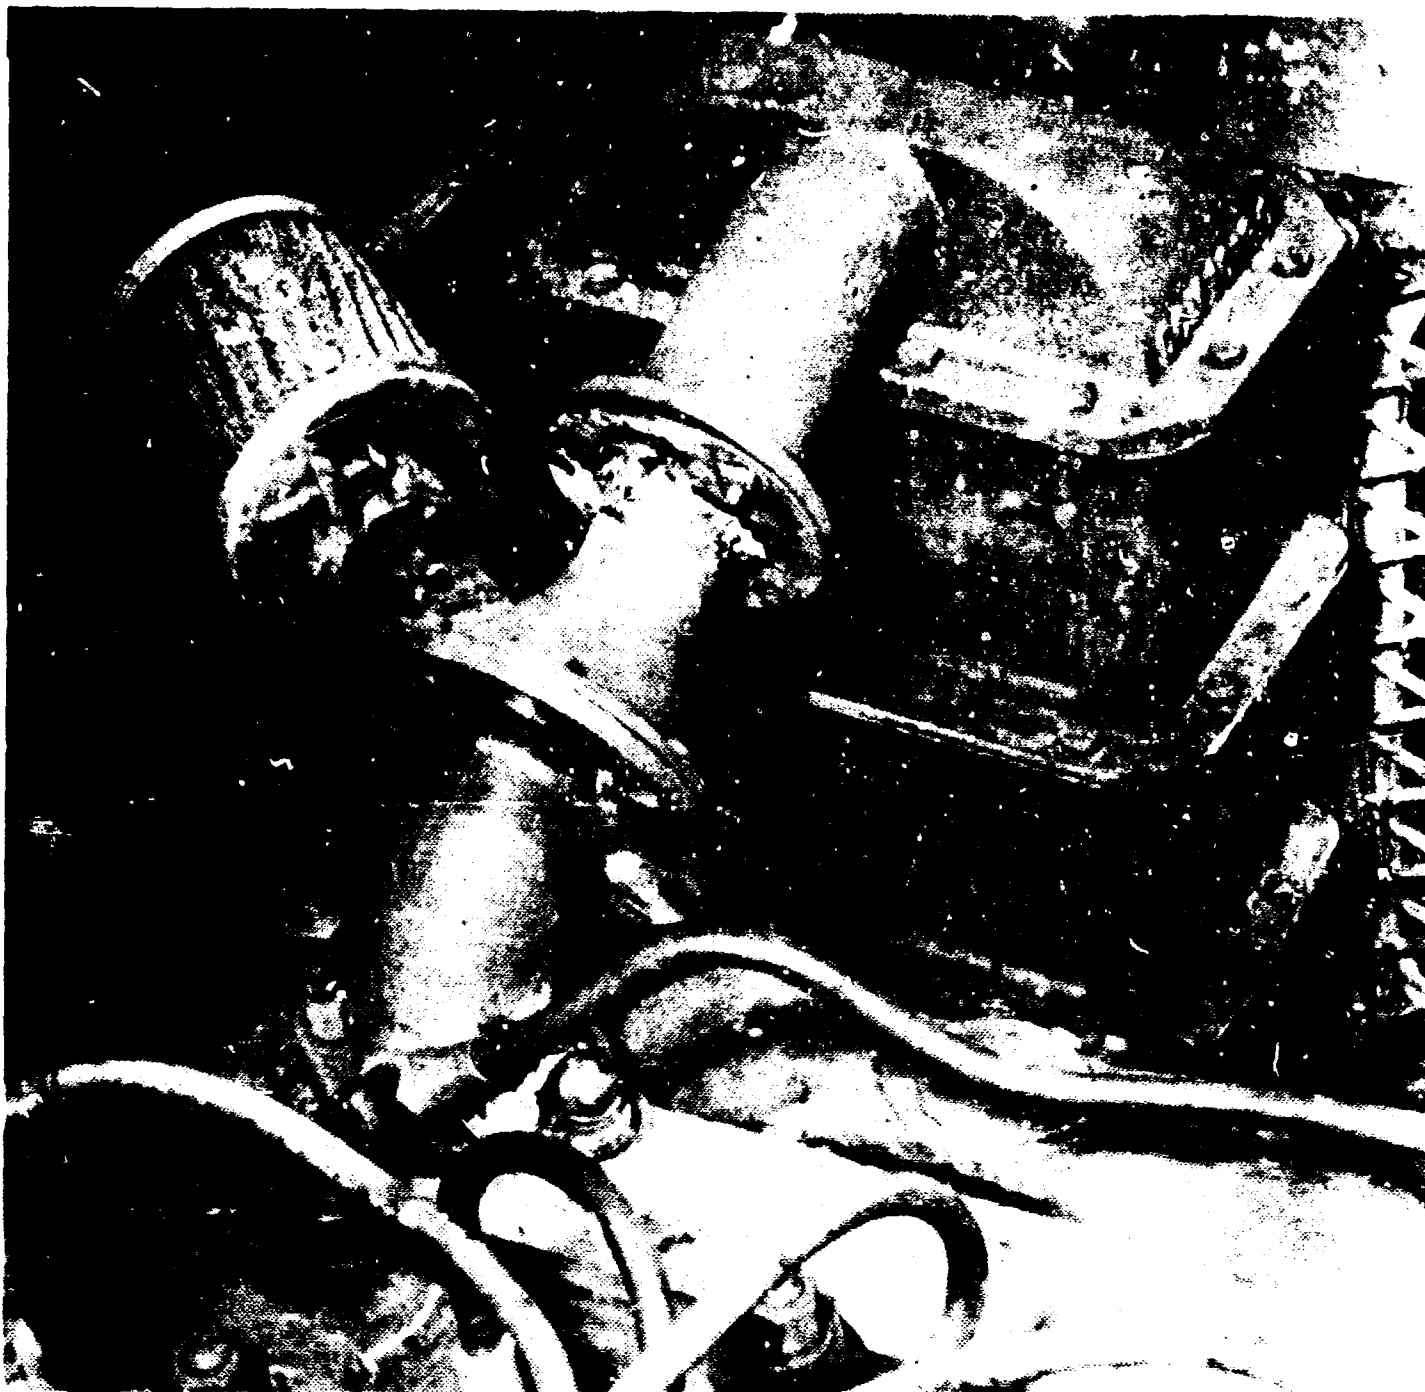
This original muffler had been broken in a number of places. The manifold flange connections had cracked and the venturi coupling had broken a number of times. These mechanical failures were due jointly to the method of supporting the muffler and the connections to the engine. Figures 1 - 4 show the various parts of this muffler and the manner in which it was fastened to the Tomotor Model LT-44 fork truck. Figure 1 shows that the entire weight of the muffler is supported by means of the manifold flange connection. Figure 2 shows how this overhanging load has caused the flanged connection to crack and also shows the weld repairs. Figure 3 shows the failure at the flanged end of

**FIG. 1 METHOD OF CONNECTING AND SUPPORTING MUFFLER SHOWING
HOW ENTIRE WEIGHT IS PLACED ON MANIFOLD FLANGE AND VENTURI
SECTION (USNSRDF NEG. NO. RDF-596-1)**

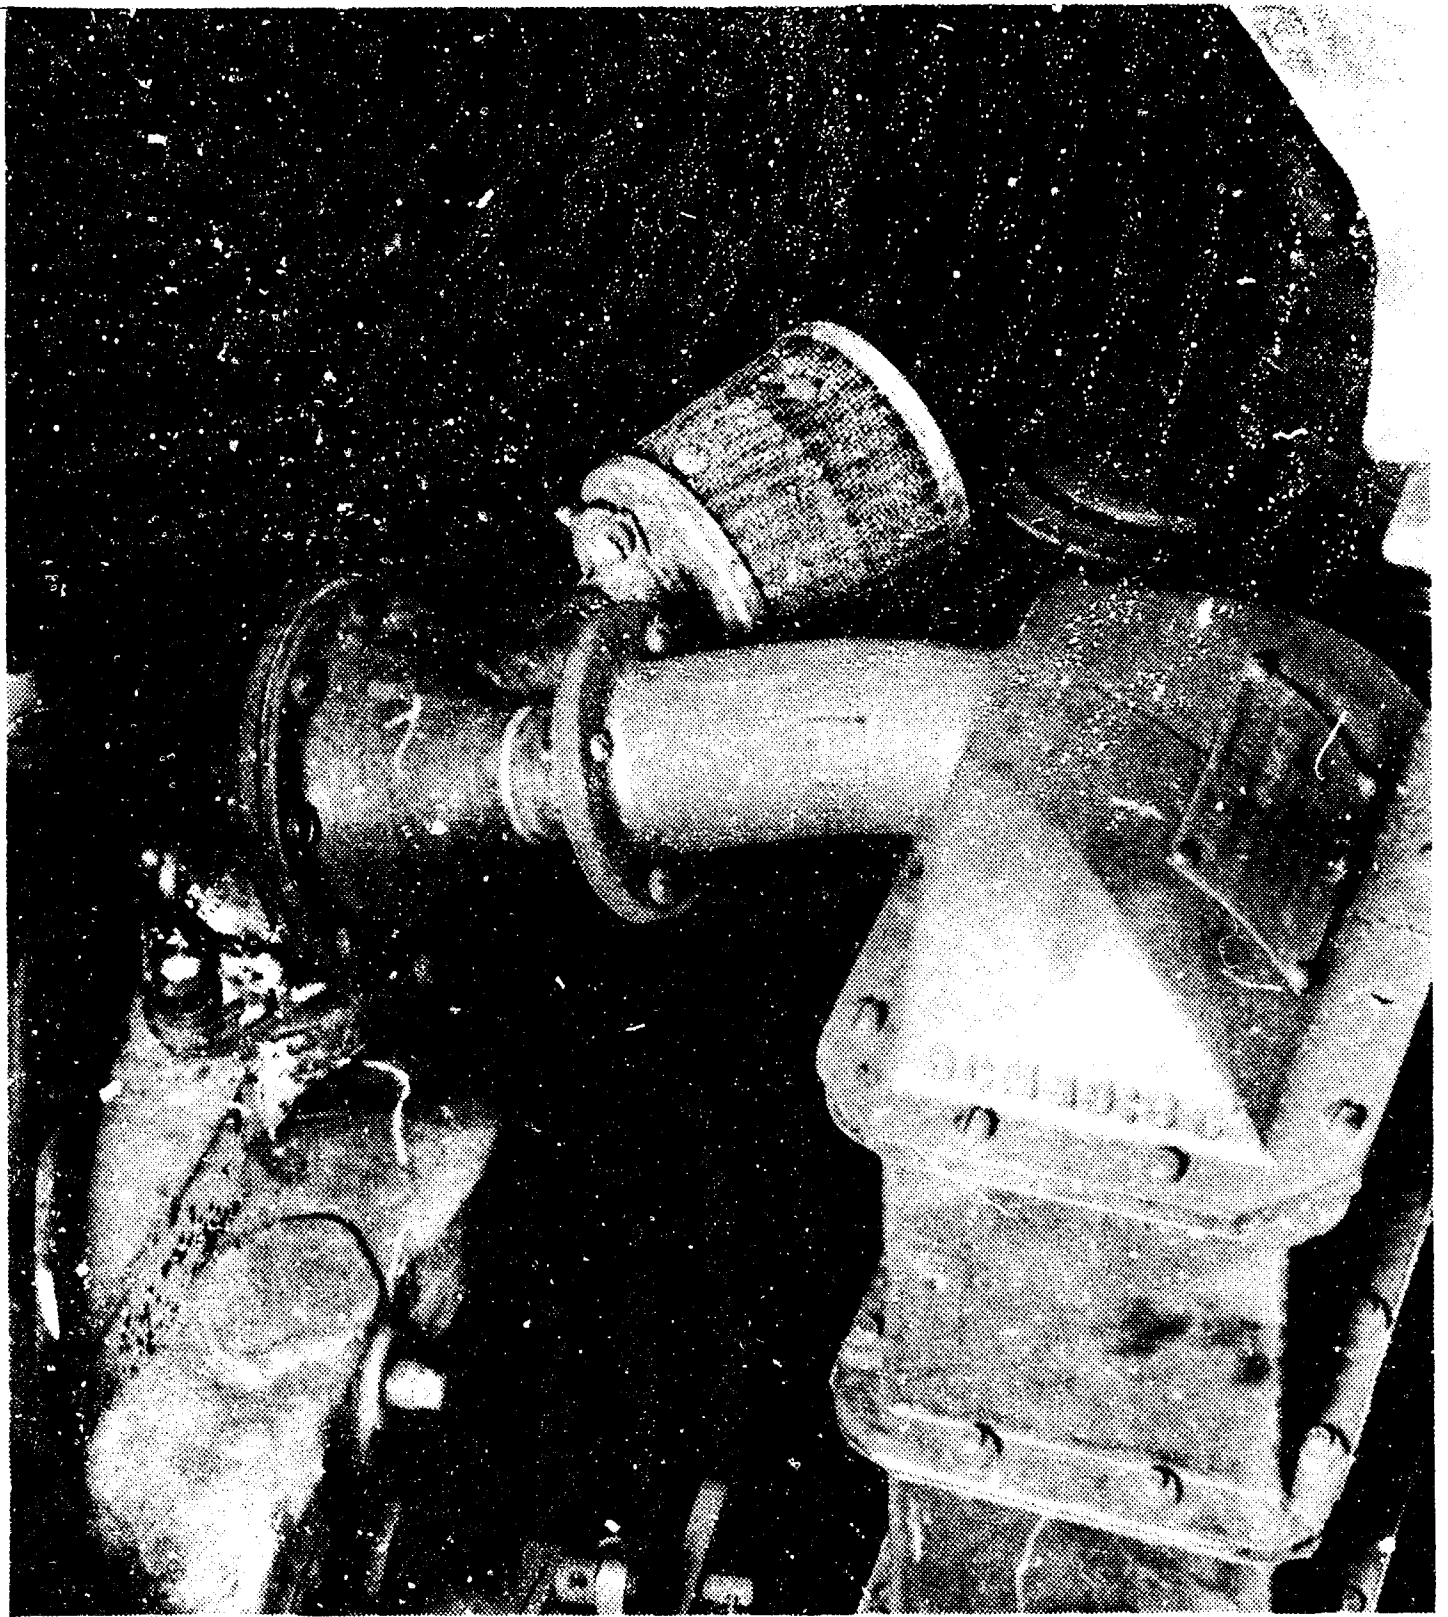
FIG. 2 ILLUSTRATION OF REPAIRS NECESSITATED BY CRACKING OF FLANGE DUE TO WEIGHT OF MUFFLER. (USNSRDF NEG. NO. RDF-596-2)

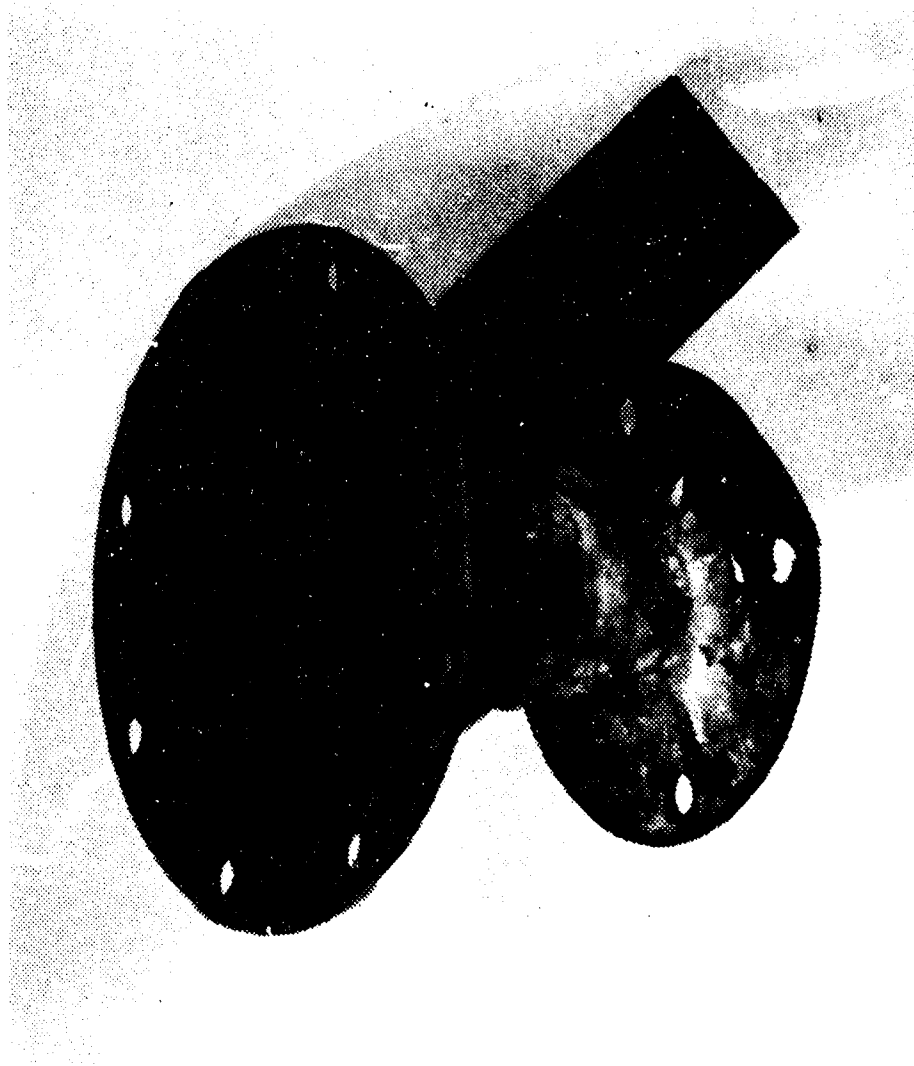
the venturi and the manifold coupling. Figure 4 shows a second failure of the venturi flange after repairs had been made. Note the very light gauge material that has been used in the venturi as compared to the heavy cast flange to which this piece connects.

**FIG. 4 CLOSE-UP OF SECOND FAILURE OF VENTURI
FLANGE ASCRIBED TO THE USE OF LIGHT GAUGE METAL
AT THIS POINT. (USNSRDF NEG. NO. RDF-596-4)**

These failures led to a search for a new method of fastening the muffler to the engine and for supporting the muffler more adequately. A method of connecting the manifold to the muffler by means of a flexible coupling was attempted. See Figure 5. In this method the muffler was fastened rigidly to the frame and the flexible tubing was designed to take out the vibration between the engine and the frame. This method of coupling is presently under test.

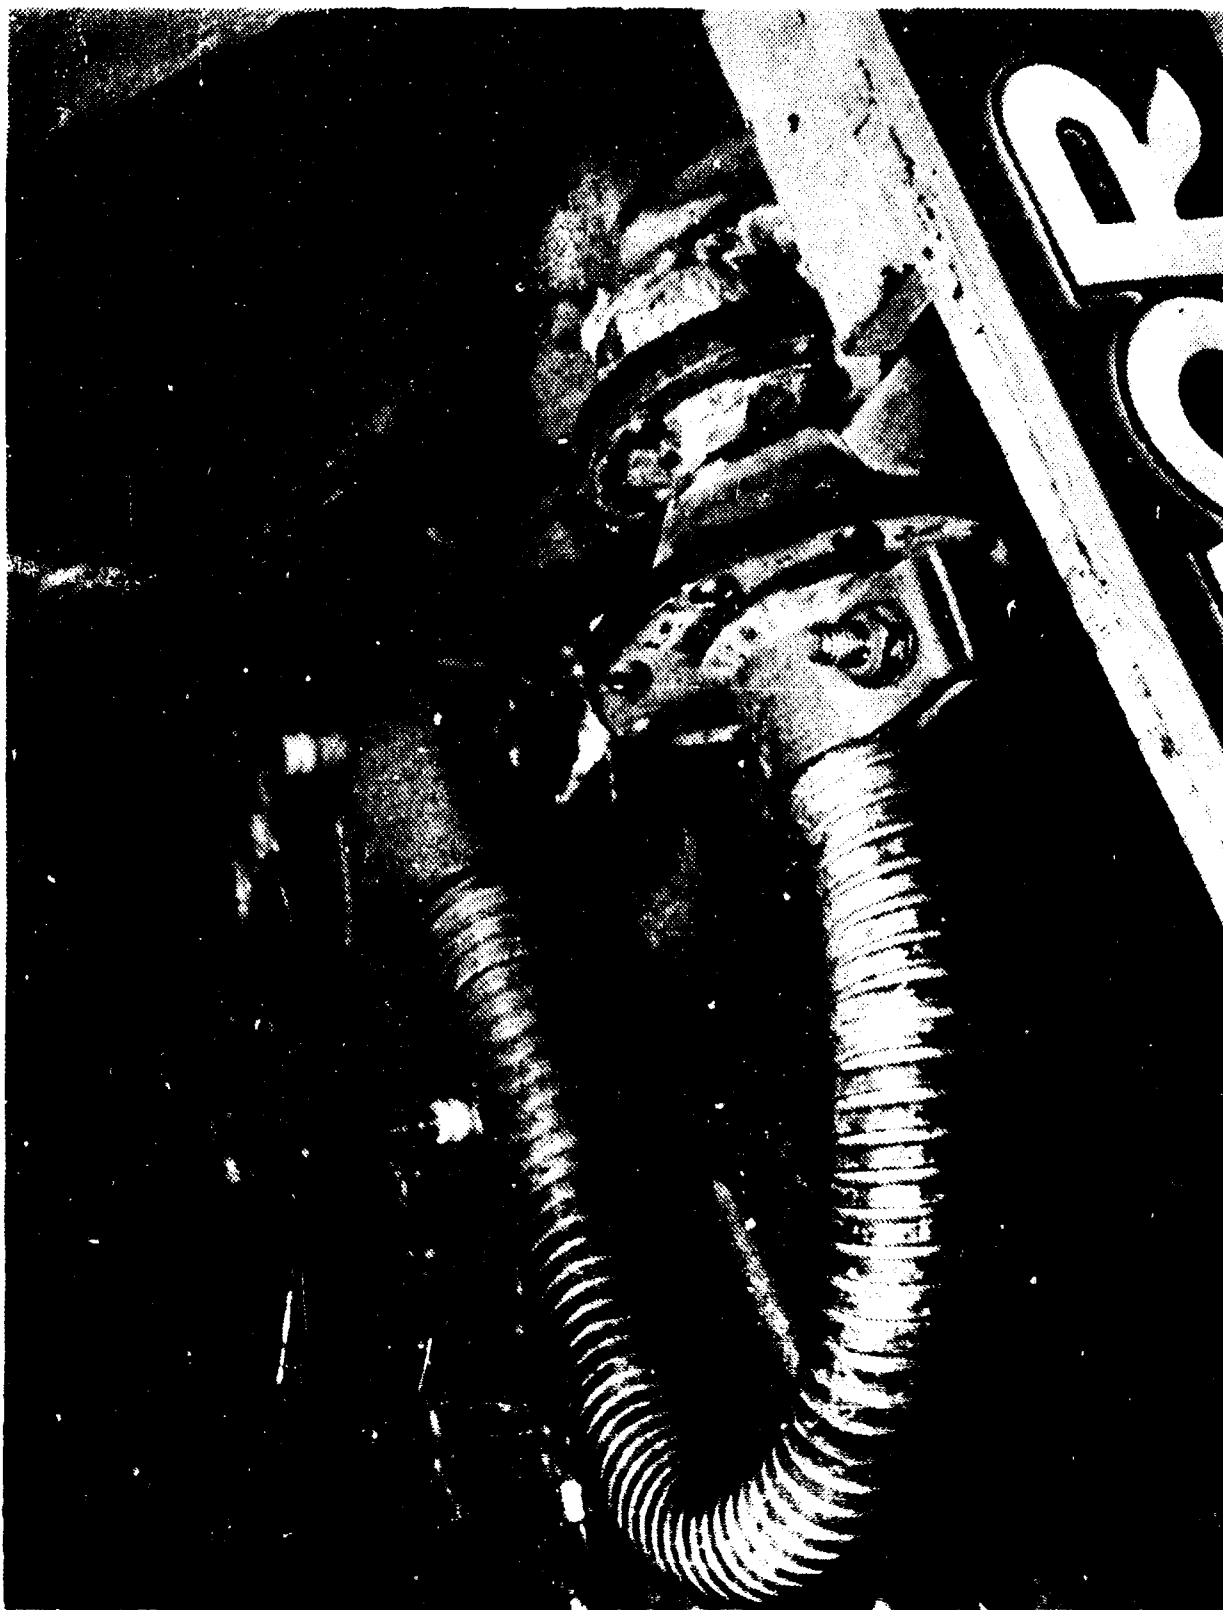
**FIG. 5 CLOSE-UP OF MANIFOLD CONNECTION SHOWING USE OF FLEXIBLE HOSE
IN AN ATTEMPT TO ELIMINATE BREAKAGE OF THE VENTURI.
(USNSRDF NEG. NO. RDF-26-2)**

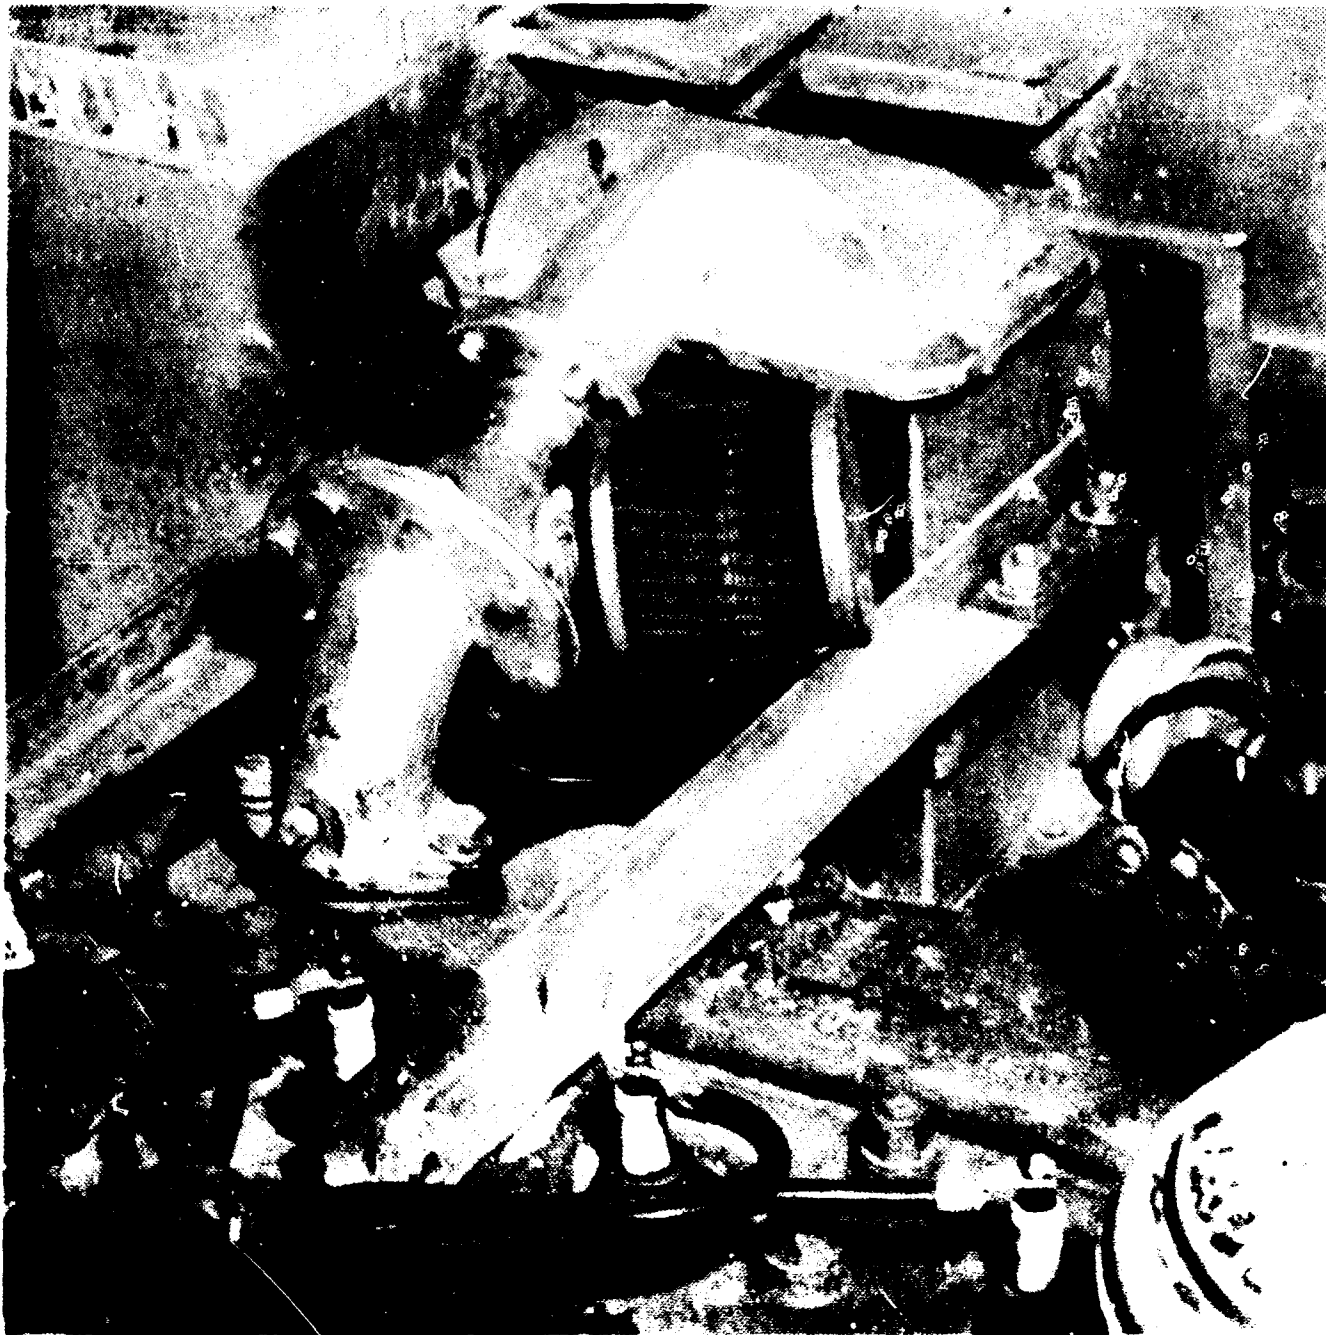
The five mufflers for use on the 4,000 lb., Model LT-44, Towmotor machines at Norfolk were installed the week of September 7th with the assistance of a company representative. The five machines had been previously prepared in accordance with Instruction Manual SEDR 009^{4/}. These mufflers used a different method of support than that previously employed by the Oxy-Catalyst Company. The muffler is supported by means of two arms fastened to the engine head studs, as shown in Figure 6. The muffler is supported in a cantilever fashion and vibrates with the engine. This method of fastening has its drawbacks

FIG. 6 METHOD OF INSTALLING MUFFLERS ON TOWMOTOR TRUCKS AT NORFOLK SHOWING SUPPORT BRACKETS FASTENED TO ENGINE HEAD STUDS (USNSRDF NEG. NO. RDF-26-1)

The mufflers failed to operate on occasion, and it was learned that breaks of the manifold flange, similar to those on the original muffler, had occurred. Three machines developed water leaks about the head stud bolts. This was due to fastening muffler brackets to the engine stud bolts.

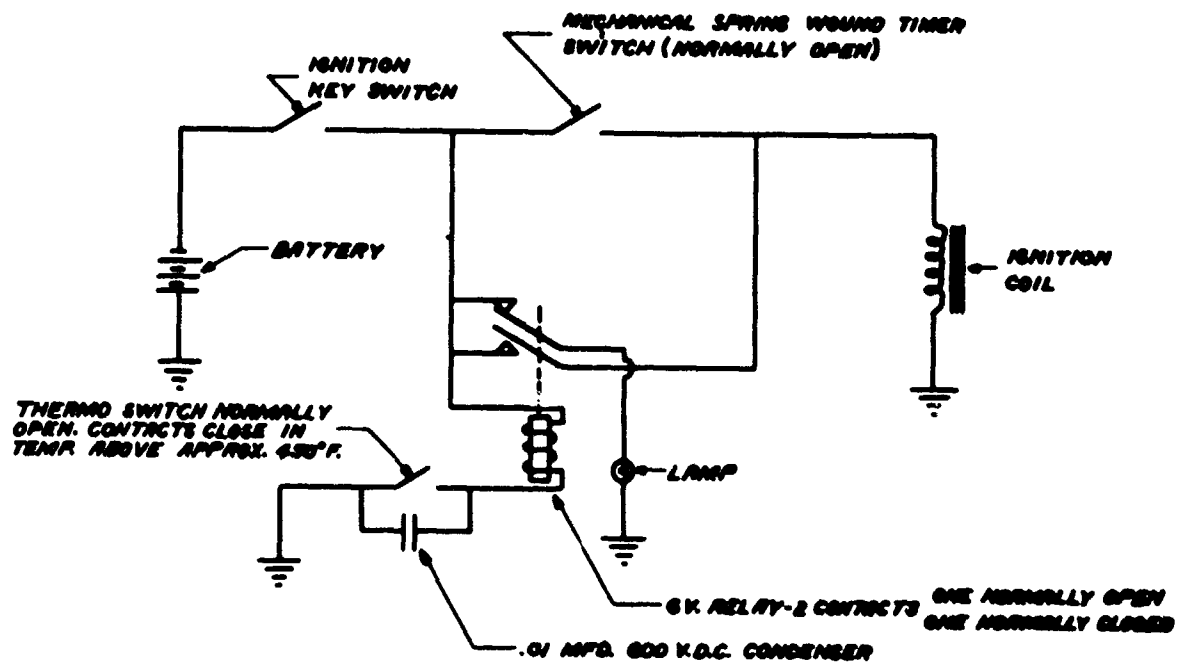
At the time of installation at Norfolk an ignition cut-out system was placed on each machine. See Figure 7. This system provided a means of turning off the engine automatically if the catalyst failed to come up to temperature. The ignition cut-out system showed signs of failure at the time of installation, and two units were inoperative before the company representative left. The three other units failed shortly thereafter and the machines were operated without the alarm system. It is believed that the units failed because the delicate clock and relay mechanisms were unable to withstand the shock and vibration imposed on them.

FIG. 7 - ALARM DEVICE USED ON FIRST INSTALLATIONS . LATER REPLACED.

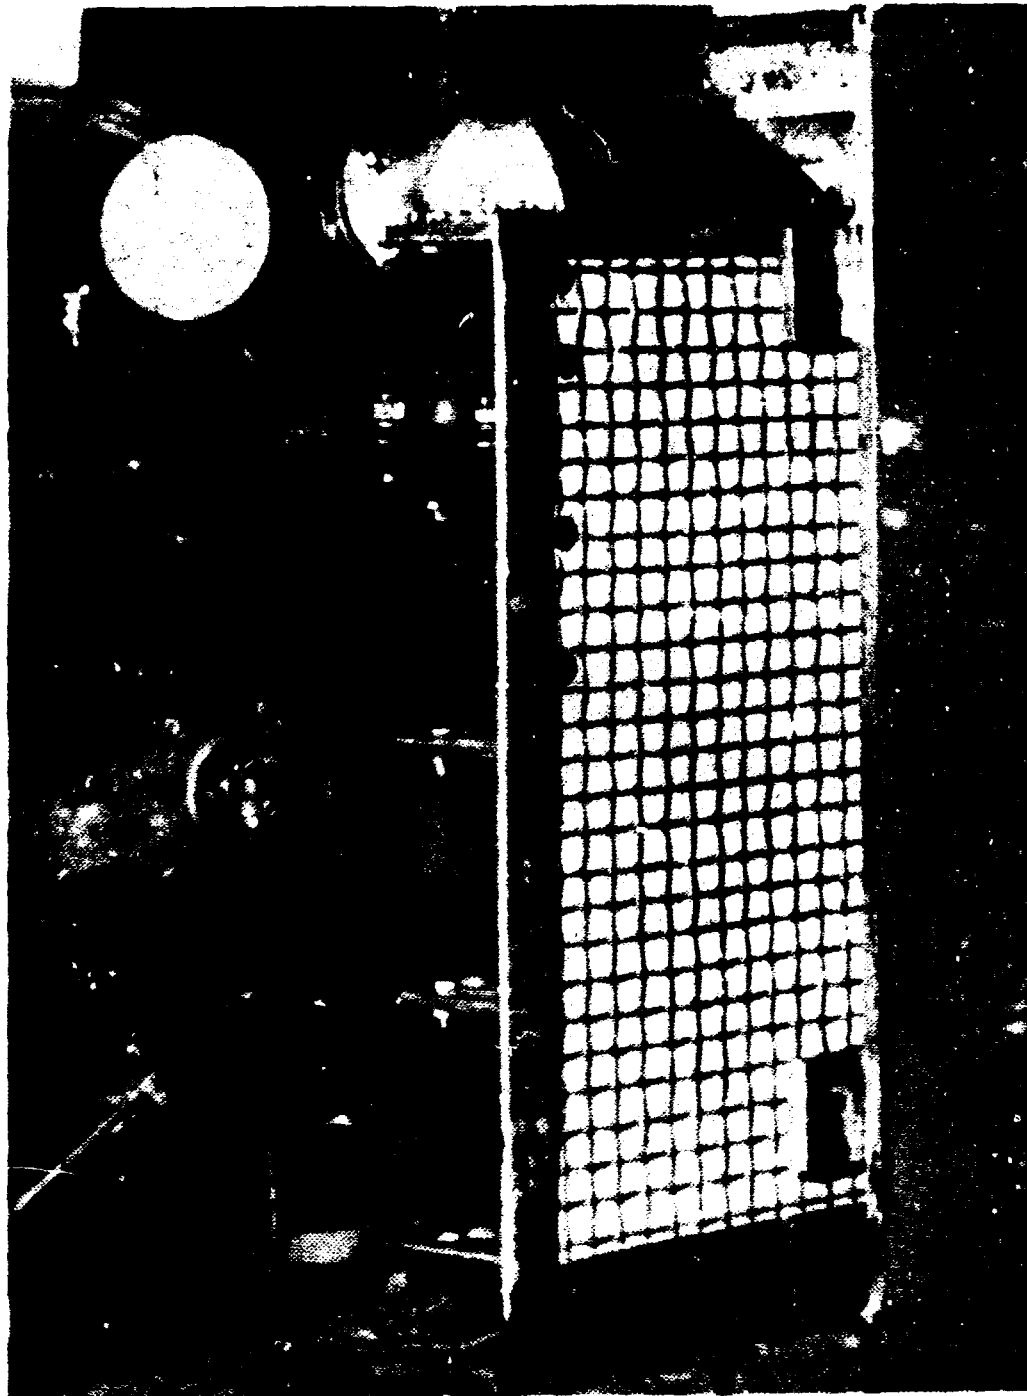
**FIG. 9 HEAT SHIELD DESIGNED AT USNSRDF TO
OVERCOME EXCESSIVE RADIATION EFFECTS.
(USNSRDF NEG. NO. RDF-13-i)**

This activity recommended that a "sandwich" of asbestos and metal be placed between the face of the muffler and the side walls of the truck. This measure alleviated the condition. Such a heat shield installation is shown in Figure 9.

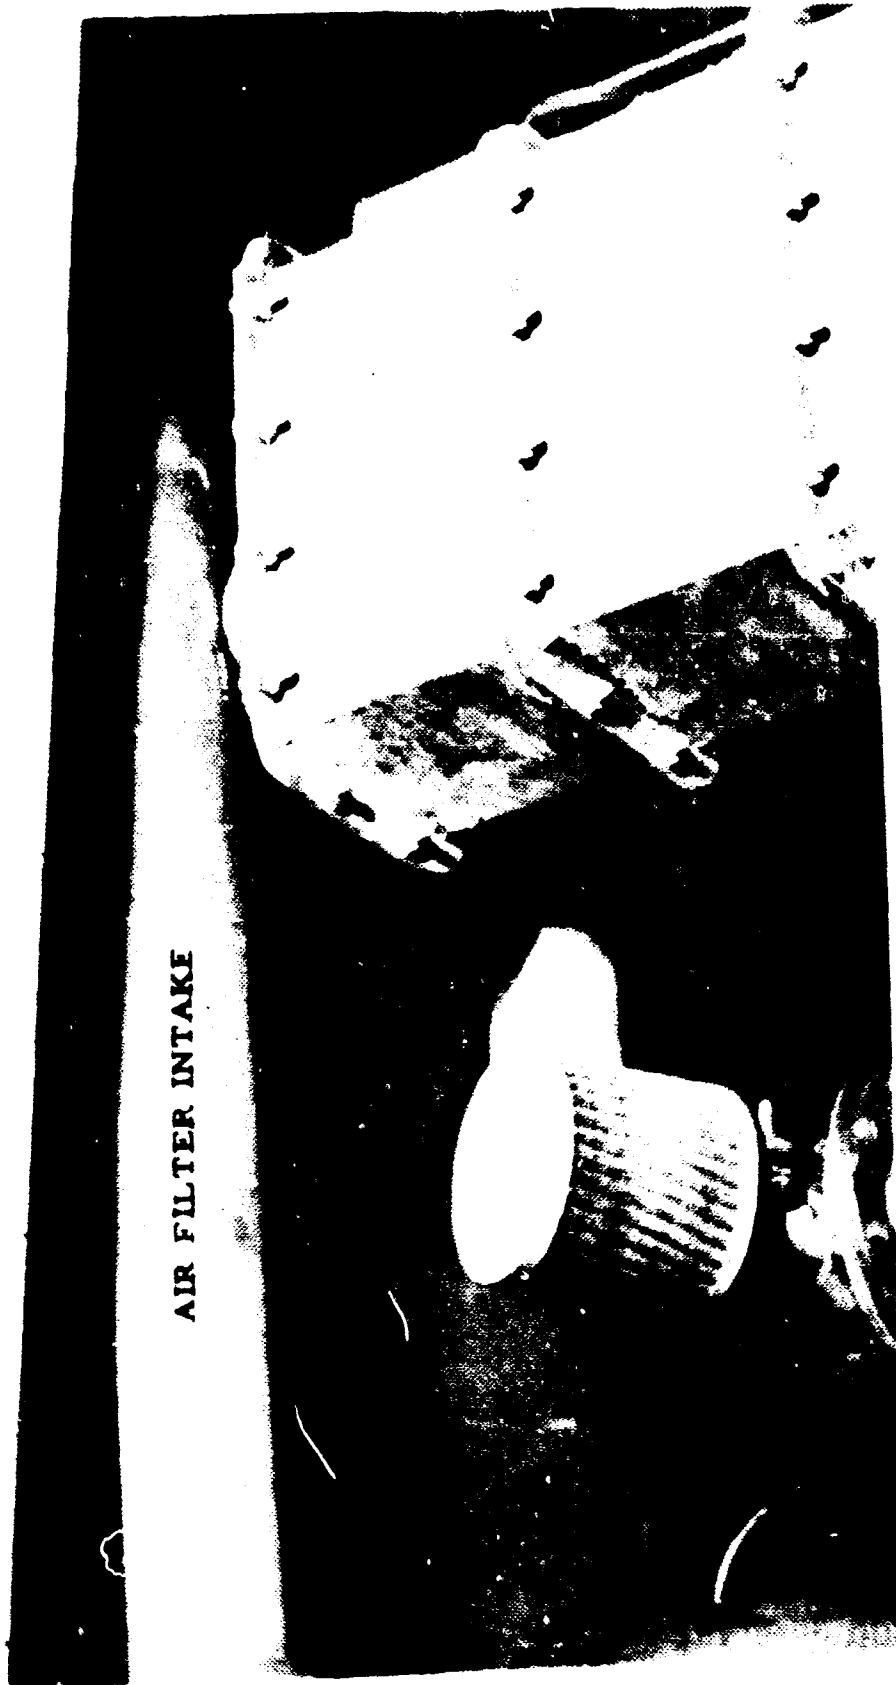
The attachment of a muffler to the Clark "Carloader" necessitated the relocation of the carburetor air in-take pipe. See Figure 15. It was directly in the path of the muffler manifold connection. The muffler manufacturer recommended that the muffler be fastened to brackets provided for the truck's original muffler. This was not advisable without increasing the strength of these brackets by means of stiffeners. The clamp provided by the muffler manufacturer to fasten the muffler to the support bracket did not grip the muffler securely. It relied on supporting the muffler without holding it rigidly. See Figure 16. A new clamp was designed, along with the reinforced support bracket, as shown in Figure 17.

FIG. 15 INTERFERENCE BETWEEN MUFFLER AND AIR FILTER INTAKE ON CLARK "CARLOADER". (USNSRDF NEG. No. RDF 26-3)

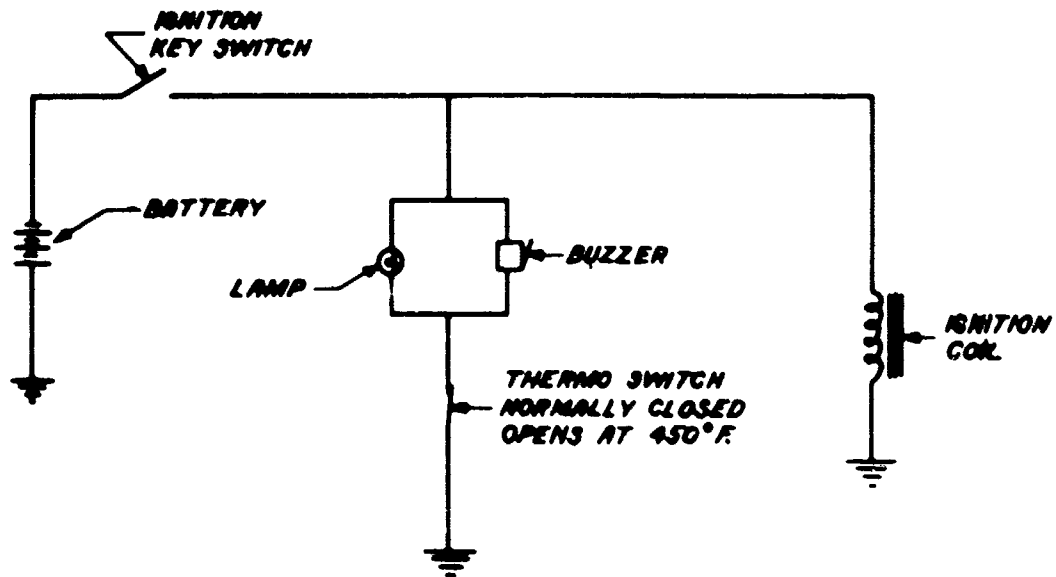
An audio-visual alarm has been mounted on these five machines incorporating a new circuit design. See Figure 18. The circuit now operates on a thermal switch that is closed until the muffler comes up to temperature. See Figure 19. The closed circuit switch energizes a buzzer and danger lamp that remain on until the thermal switch opens

FIG. 19 - REDESIGNED ALARM SYSTEM NOW IN USE.

and the circuit is broken. This alarm system has been found to operate satisfactorily and will indicate proper muffler operation as long as the engine is not operating continuously under heavy load. Under this condition, the temperature of the exhaust gases may be high enough to keep the alarm off, although the muffler is not operating properly. The Underwriters Laboratory, Inc. confirms this in a report^{6/} on the catalyst muffler.
